# Manhole Inspection Summary

Manhole # S29GG2017MH

**Location** Address: **12 CHARLESMEAD AVE**

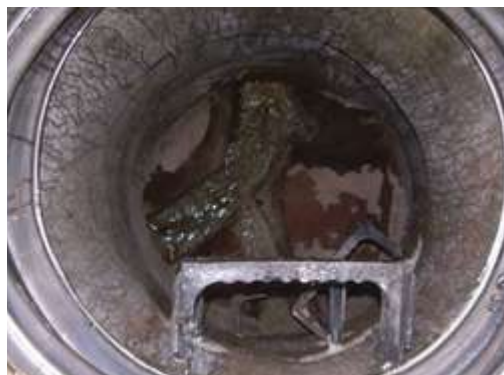
Top View

Infiltration: ☐ None ☒ **Joint** ☐ Cracks ☐ Mortar ☐ Roots ☐ Wall

Infiltration: ☐ None ☐ Joint ☐ Cracks ☐ Mortar ☐ Roots ☒ **Wall**

Adjustment and Barrel infiltration.

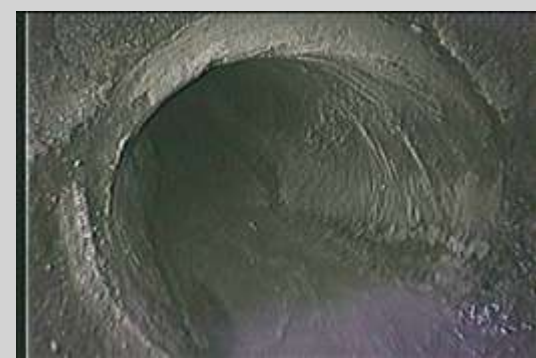
### 15 in. Circular Gravity Sewer Pipe Out @ 12 O'Clock

Infiltration: **Evidence** Pipe Seal Cond: **Unknown**

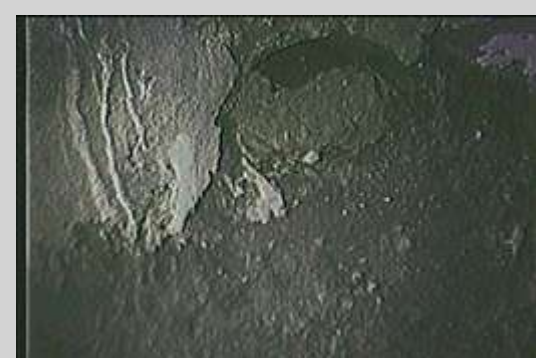
### 8 in. Circular Gravity Sewer Pipe In @ 3 O'Clock

Deposits: ☐ None ☒ Mud ☐ Sludge ☒ Debris ☒ Grease

Silt Depth: **3** (in.) Deposits Extent: **Medium**

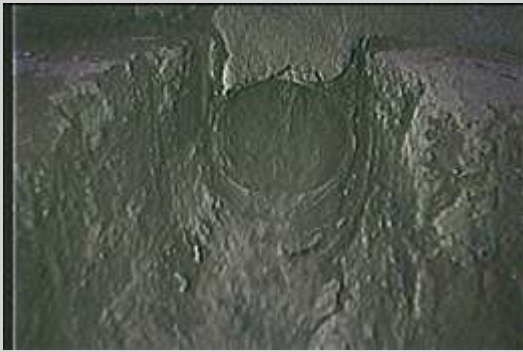
### 8 in. Circular Gravity Sewer

Infiltration: **Evidence** Pipe Seal Cond: **Cracked**

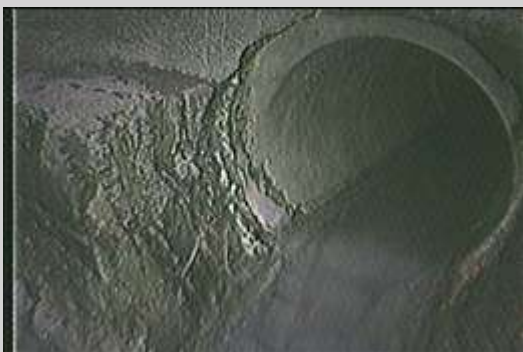
### 15 in. Circular Gravity Sewer

Condition: ☐ Sound ☐ Cracked ☒ **Root Intrusion** ☒ **Deteriorated** ☐ Leaks ☐ Debris

Channel deterioration and root intrusion.

Infiltration: **Evidence** Pipe Seal Cond: **Unknown**
